Seismic performance of multi-storey cross laminated timber shear walls with high-capacity anchoring systems

Minghao Li, Ben Moerman, Thomas Wright, and Angela Liu

Executive Summary

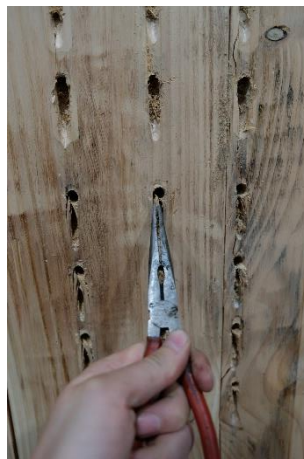
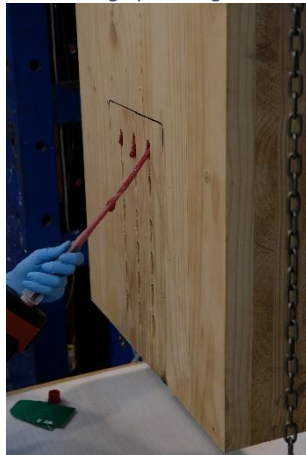
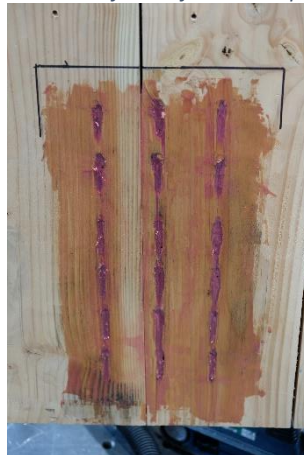
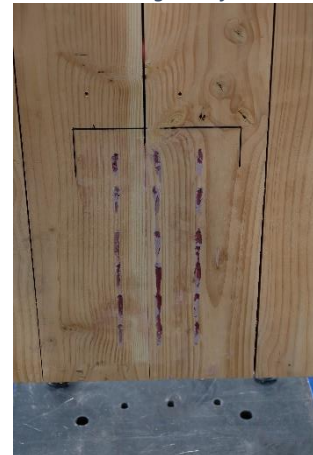
Figure 2 – Repair Process

Figure 2 shows the repair process with epoxy. The first step is to repair the damage to timber caused by the inclined screws withdrawing, and the 90 degree screws bearing under the fastener. First the holes are cleaned of loose wood fibres. For the inclined screw holes, this is simply done by reaming the hole with a drill bit sized to suit the epoxy injection tube. For the 90 degree screw holes, the bearing results in lots of loose timber on the edges of the hole. This can be removed by hand with a chisel and pliers, or by using a handheld router to cut out the loose timber. These holes are then blown out with compressed air to remove any remaining timber fibres or dust. Epoxy is then injected into the holes

making sure that the epoxy can penetrate and fill the entire hole. In this study Hilti HIT RE-500 was used, with an extension tube being used to inject epoxy into the base of the hole similar to conventional use in concrete construction. Excess epoxy was cleaned off, and once cured the area sanded to remove any excess epoxy from the timber surface.

A – Damage post original test

B – Removal of loose fibres with pliers

C – Blowing out of dust

D – Injecting of epoxy

E – Epoxy post smoothing

F – Finished repair ready for new fasteners

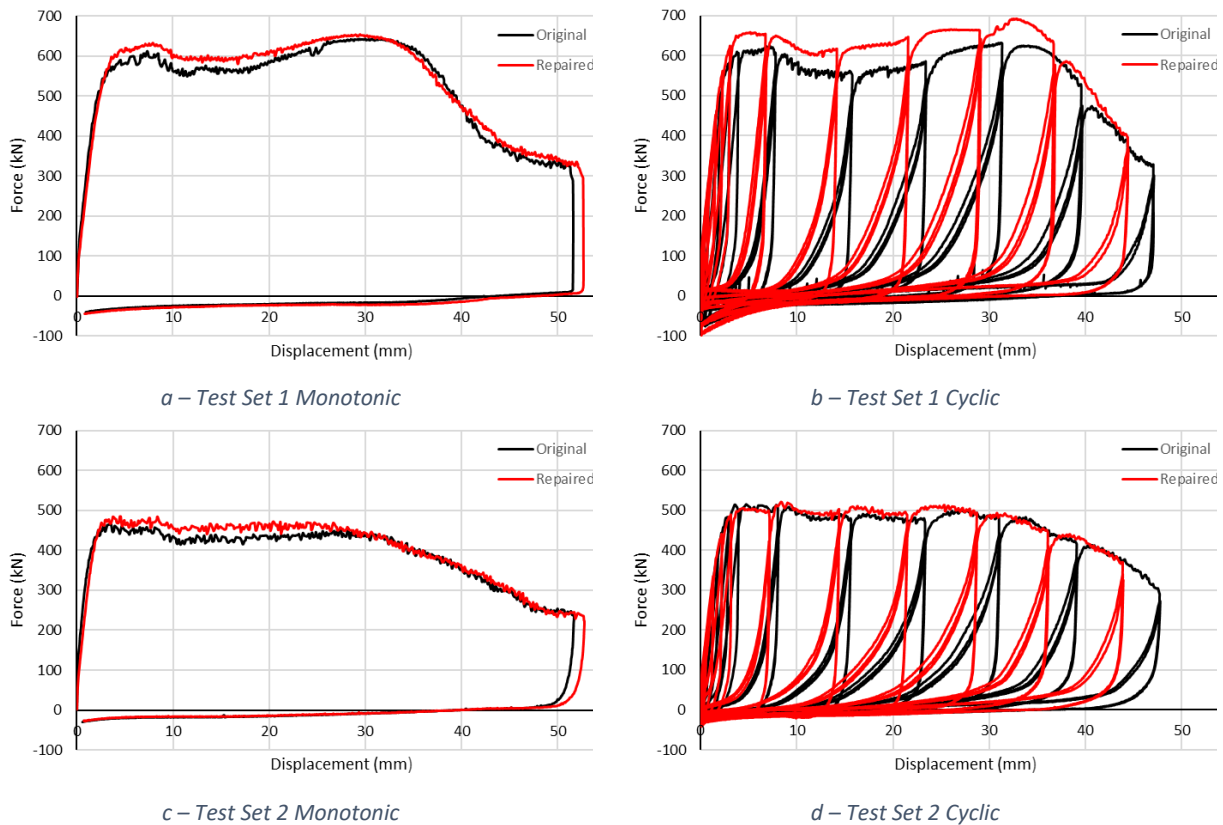
Figure 3 – Load displacement curves showing original vs repaired connections

From Figure 3c and d, it can be seen that Test Set 2 followed a similar pattern initially with a first peak at approximately 5 mm displacement followed by a drop, but in contrast to Test Set 1 has less of at 90 mm due to the reduced number of 90 degree screws. Covered in more detail by Wright et al. (2021), this

shows how the inclined to 90 degree screw ratio can be used to adjust the performance of the overall connection.

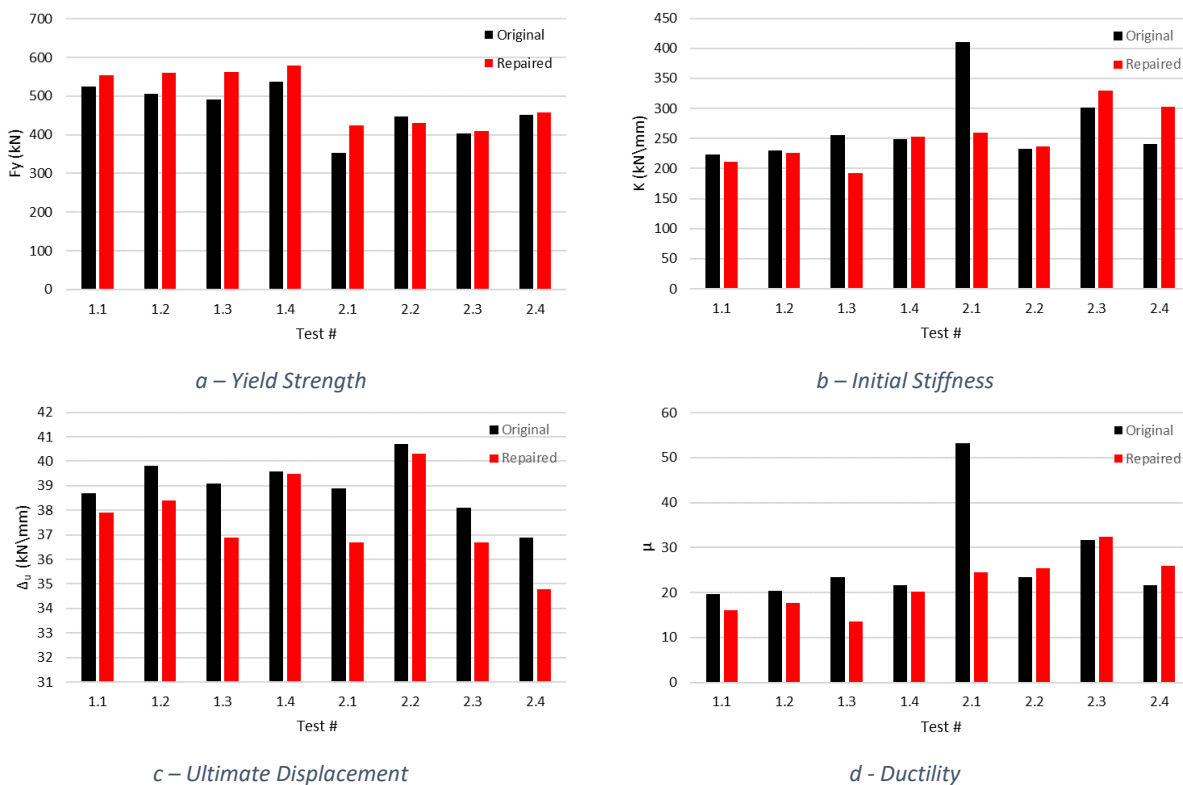
Figure 4 – Bar charts comparing original and repaired test results for key properties

A comparison of yield strength between original and repaired connections is shown in Figure 4a. It can be seen that yield strength after repair increased slightly among all tests. A statistical hypothesis t-test further confirmed that yield strength of the repaired connections was greater than the original test at a 5% level of significance. This increase in strength could be due to two factors: 1) some of the inclined fasteners may hit layers of epoxy on installation. This would lead to an increase in withdrawal strength in the inclined fasteners, and be evident on the initial peak seen in Figure 3; and 2) the epoxy may provide a local reinforcement of the timber and increase the bearing strength of the nearby 90 degree fasteners. This would lead to an increase in shear strength of the 90 degree fasteners and would be seen as a slight increase across the full displacement range, partially apparent where the 90 degree screws hit their max capacity at approximately 30 mm displacement. Based on the curves presented in Figure 3, it was most likely that the increase was due to the inclined screws hitting epoxy as the greatest increase in strength occurred at the initial peak.

Figure 4b shows the stiffness comparison between the original connections and the repaired connections. It can be seen that there is no clear trend on stiffness between original and repaired tests. A statistical t-test further confirmed that there was no significant difference between the original and the repaired connections at a 5% level of significance. The inherent variability of timber materials and the high dependence of stiffness on the initial conditions of the connection led to some uncertainty in the stiffness values reported. In this case, all screws were torqued to the same setting, but differences were observed in how well the steel hold-downs were sitting against the timber surface, and how the screws were sitting in their holes despite the best efforts to be consistent. Given the increase of yield strength, it is unlikely that stiffness in the repaired connections would decrease significantly.

Displacement capacity or ultimate displacement is shown in Figure 4c, and ductility results are shown in Figure 4d. The displacement capacity of most of the repaired specimens was still quite high although slightly lower than that of the original ones. From Figure 3, it can be seen that the load-displacement curves of the original or repaired specimens are very similar. According to EN12512, ultimate displacement is defined as the displacement where the load drops to 80% of the peak. Due to the slight increase in strength discussed previously, the definition of ultimate displacement caused the ultimate

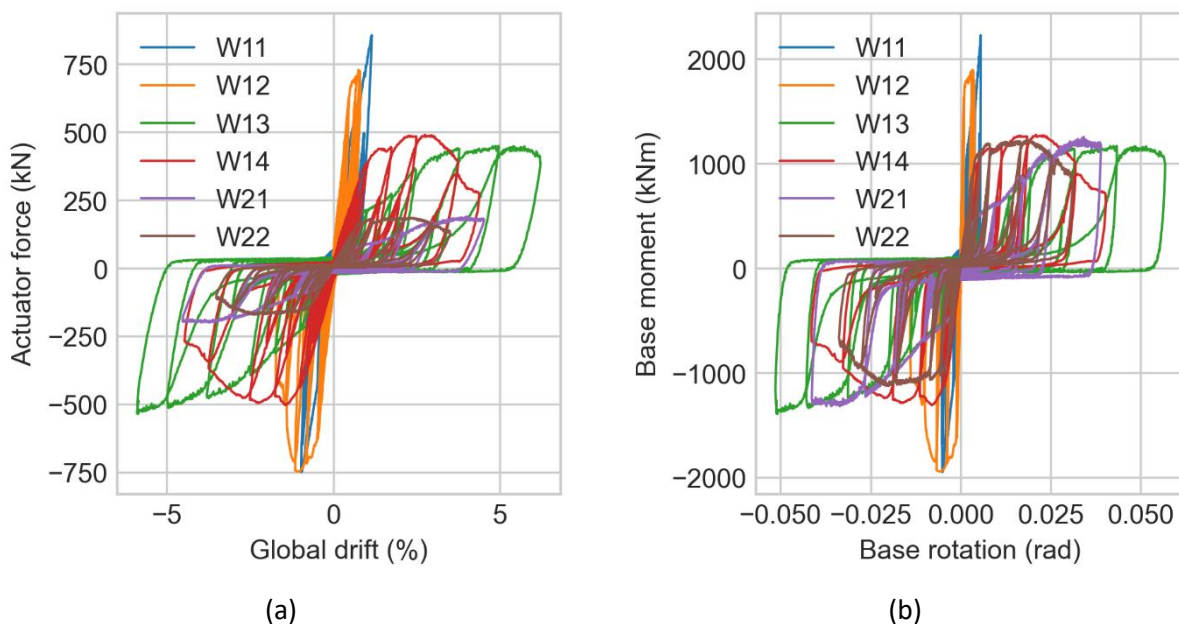
Figure 9: Cantilever wall test results: (a) global drift vs. shear force and (b) base rotation vs. base moment.

The global load-drift and moment-rotation curves of each wall is shown in Figure 9a with global drift plotted on the X axis (actuator displacement/load height). It is apparent that the hysteresis loops were severely pinched and therefore had a reduction in energy dissipation and effective stiffness. A significant portion of the global drift was due to rotation of the wall base, shown in Figure 9b.

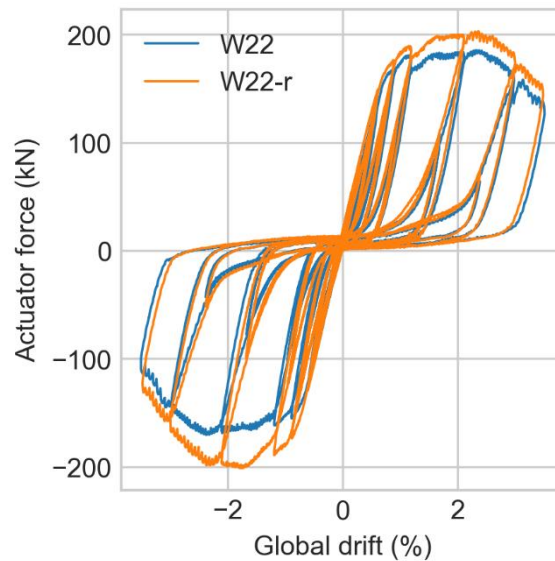
Figure 14: Comparison of global CLT wall behaviour with mixed angle screw hold-downs before (W22) and after repair (W22-r).

The global behaviour of the wall before (W22) and after the repair (W22-R) is shown in Figure 14. It can be observed that the repaired specimen behaved similar to the original wall and exhibited a moderate amount of increased peak strength (+9% positive, +18% negative). The yield strength was also greater than the original wall, particularly in the negative direction (+5% positive, +23% negative). The repaired wall initial stiffness was within 1% of the original wall's value. Therefore, the repair method was successful and provides a feasible option to consider in a post-earthquake scenario.

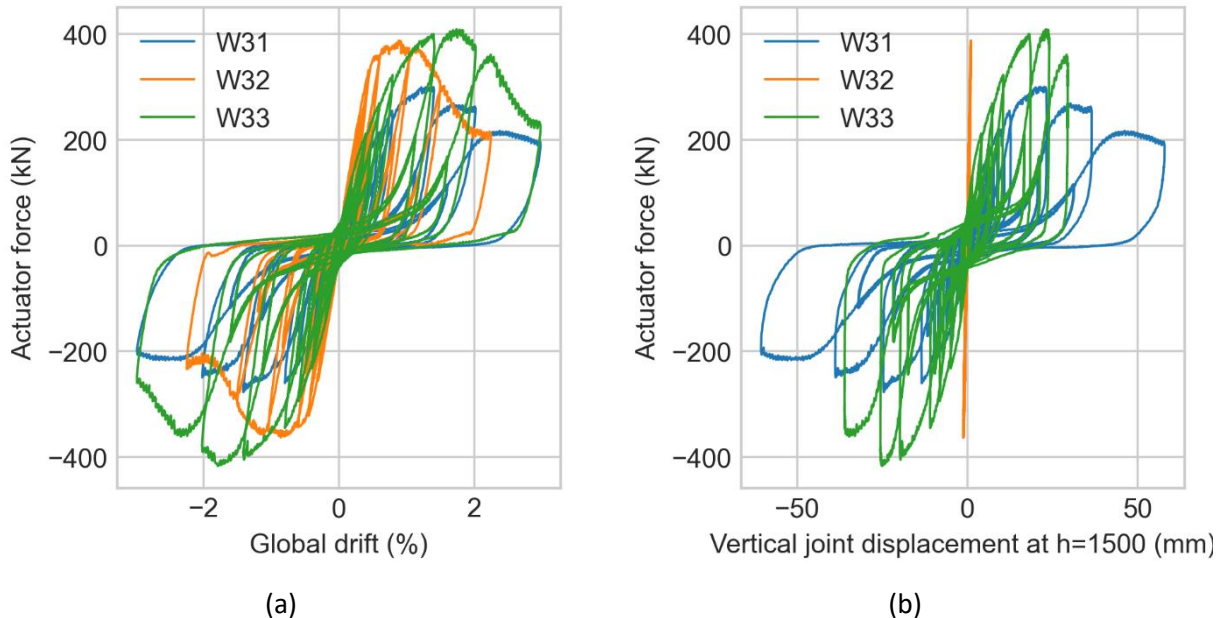
Figure 17: Multipanel CLT wall test results: (a) global drift vs. shear force and (b) vertical joint displacement vs. base shear force.

The global load-drift curves of the multipanel walls are shown in Figure 16a. Wall W32 was evidently the stiffest and reached its yield, peak, and ultimate points at the lowest displacements. While W33 achieved nearly the same peak strength as W32, it dissipated significantly more energy, as shown by the larger hysteresis loops.

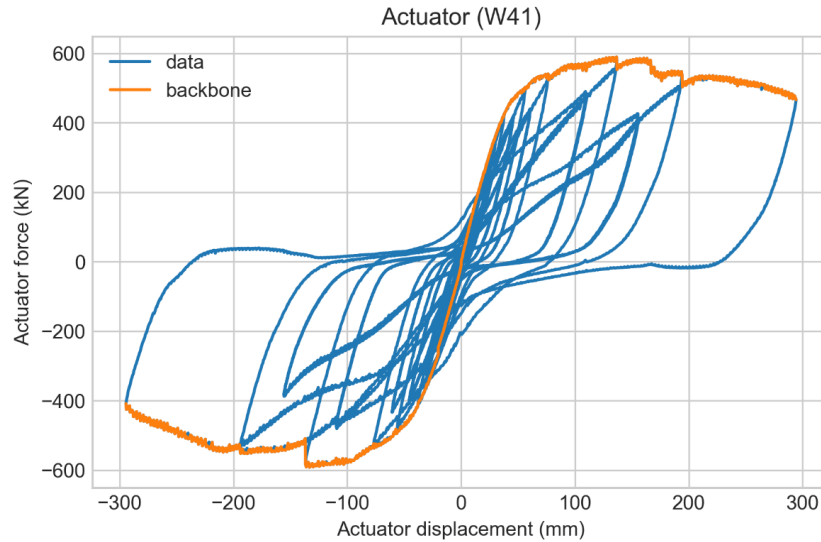
Figure 24: Global behaviour of hybrid coupled CLT wall.

Table 8 lists the key test results. This wall was significantly stronger than the corresponding multipanel wall due to the contribution of the steel link beams. The peak strength increased by 41% compared with the strongest multipanel wall W33 (590 kN vs. 418 kN). The ductility of this wall was significantly greater than those of the cantilever or multipanel wall series. Additionally, the hysteresis loops, shown in Figure 24, were much fatter than those of the cantilever or multipanel walls because the yielding of steel link beams did not create the pinching effect that is typically observed in timber dowel-type connections.
